Appendix 5-4

Arboricultural Impact Assessment

Gas Networks Ireland (GNI)

'Newtown Pipeline'

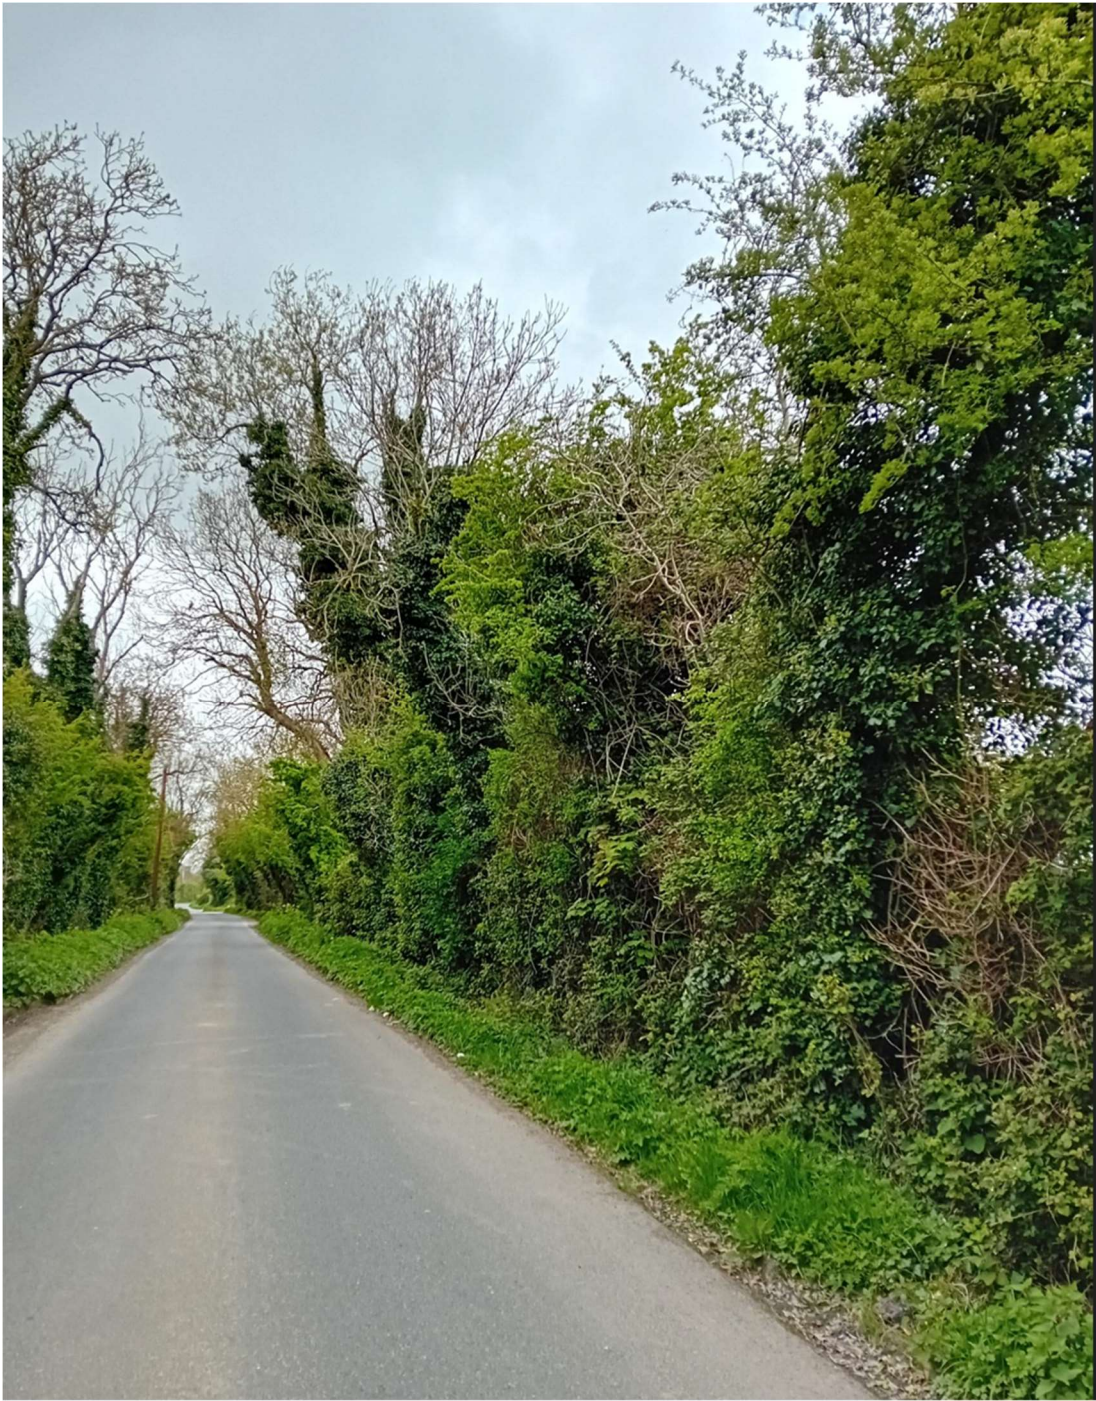
Tree Along Bay Lane

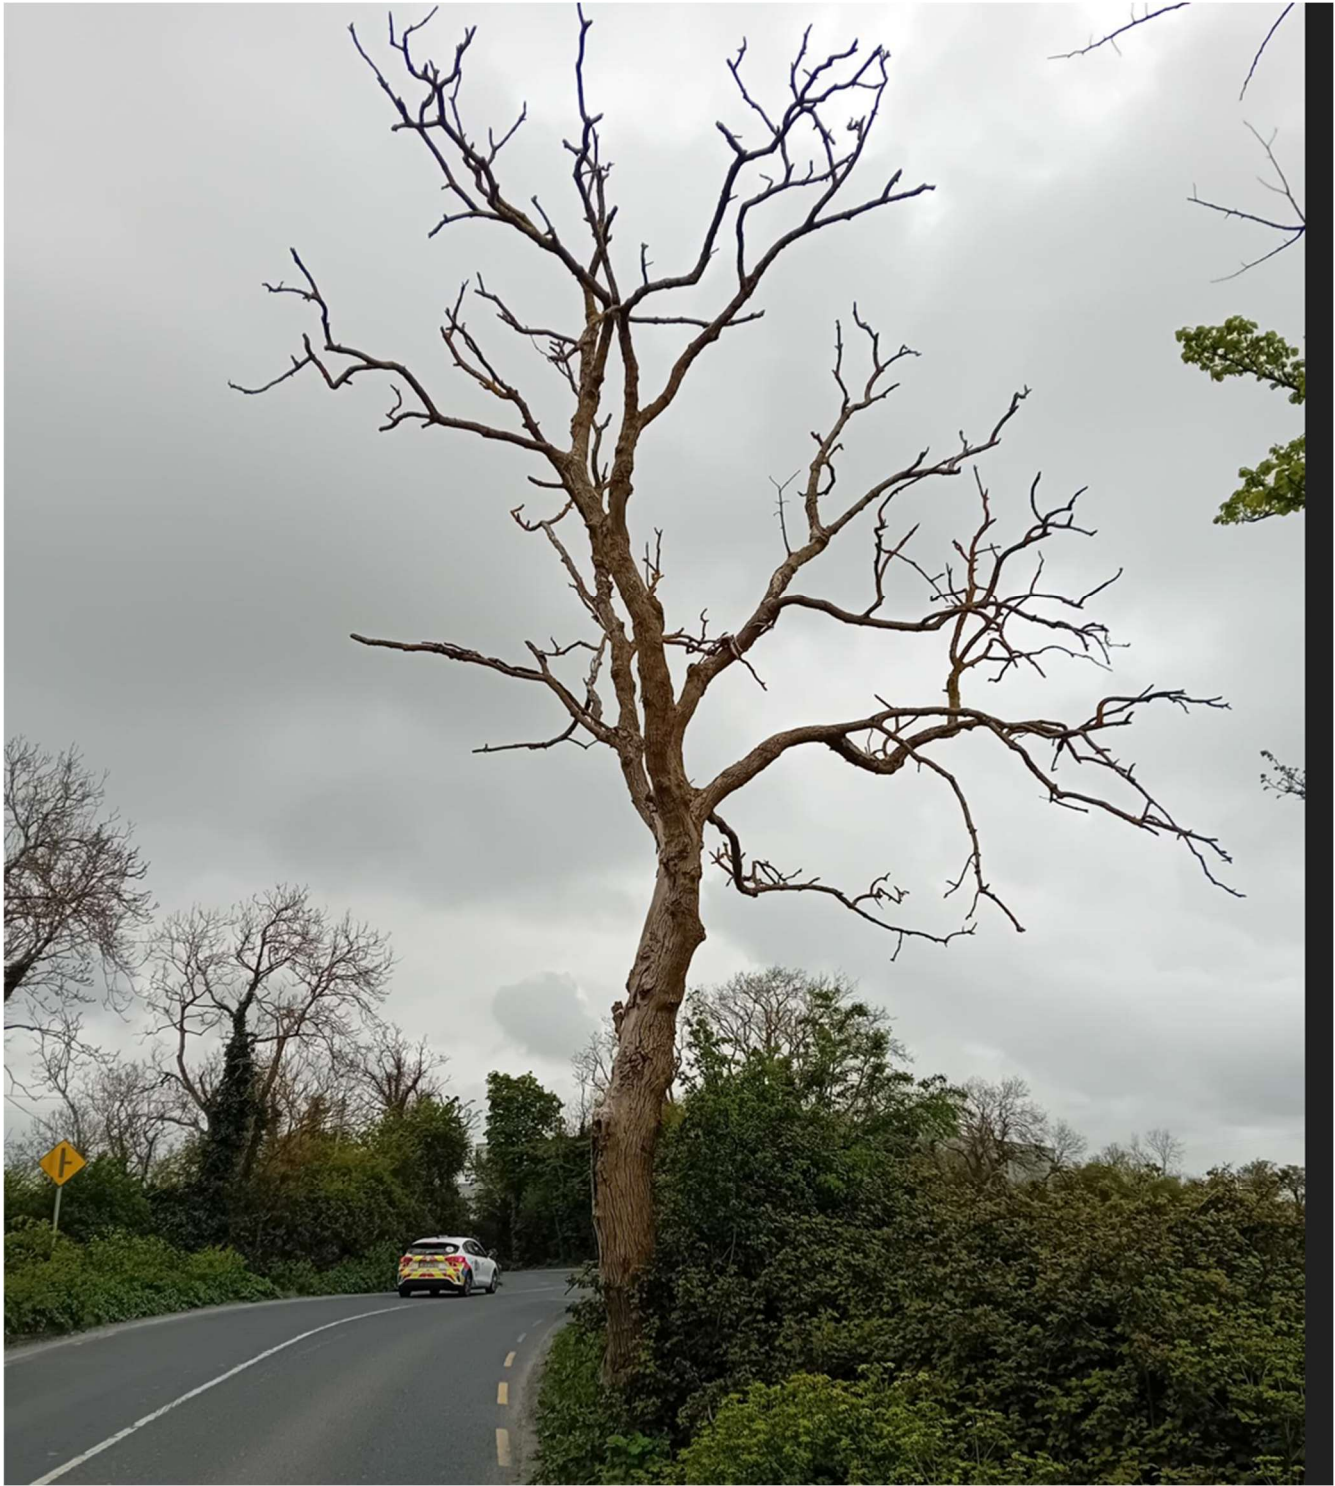
There are examples of dead and or trees in advanced decline, these are posing a hazard to road users and although they will not be impacted on by the pipeline, in the interest of health and safety they should be removed. These trees are under the authority of Fingal County Council who are responsible for their removal. In the interest of Health and Safety , the respective owner of the trees should be made aware of the poor condition of the trees due to the risks they pose.

A dead and dangerous trees along Kilshane road
