Utility Survey Report

Project Name – Kilshane Block Valve

Project Number – 54172

Client – Fingleton White & Co Ltd

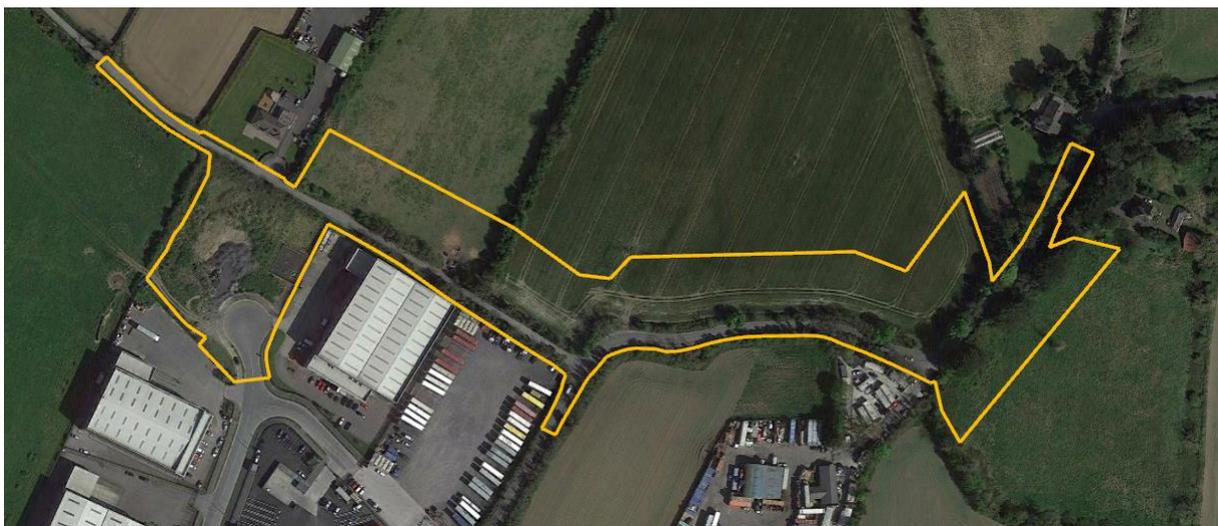
1.4 Site aerial view

Survey area outlined in yellow.

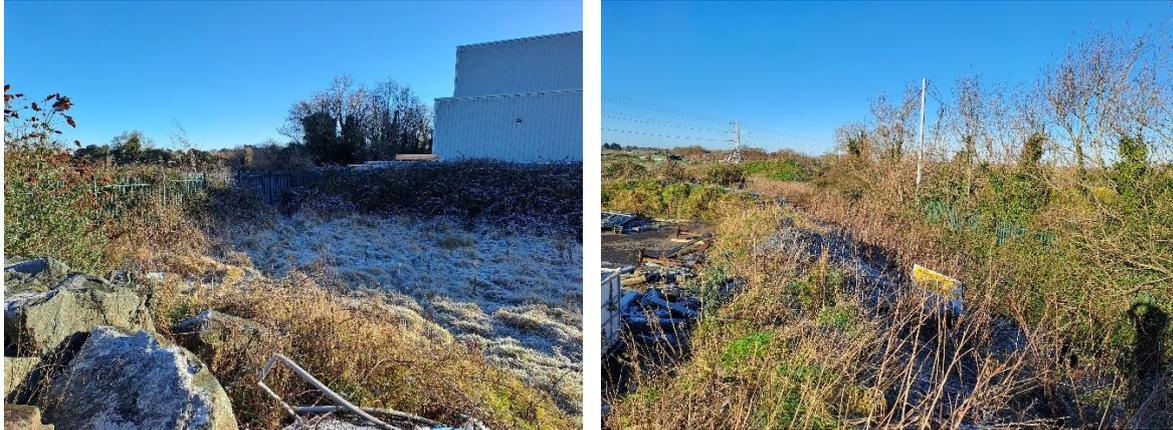
Due to unsuitable ground conditions (overgrown vegetation / uneven surface), some parts of the site couldn't be scanned with GPR radar and EML scan was carried out where possible only – please refer to the drawing.
